SPECTRAL VIBRATION SURVEY

OPPORTUNITY STREET

2023-03-19

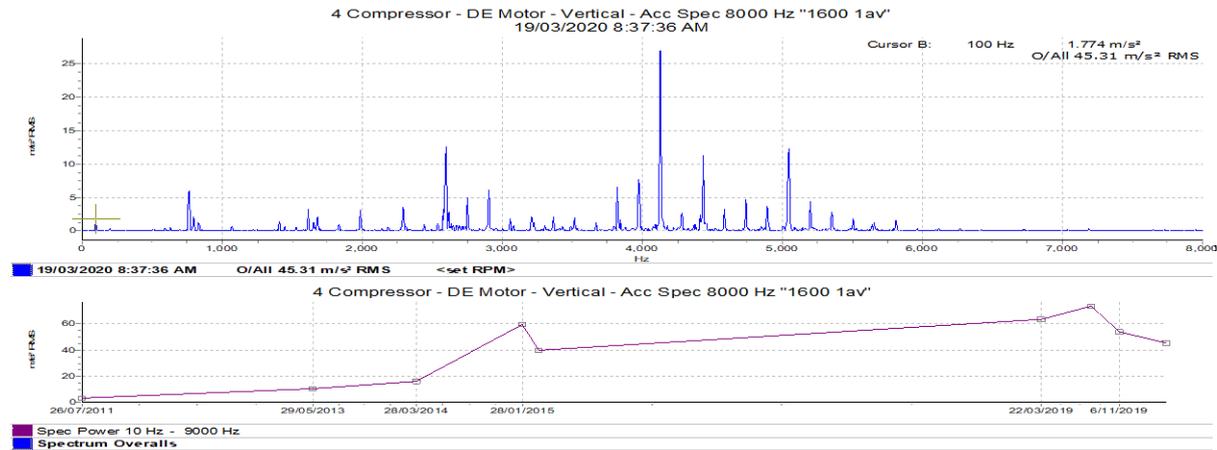
[NH3 Compressor - DE Motor - Vertical - Acc Spec 8000 Hz "1600 1av"](#)

Power 10 Hz - 9000 Hz Danger by 100.7% (Danger). The motor drive bearing has a third stage bearing wear alarm. The historical trend shows no increase. This requires a replacement bearing as soon as possible; I will continue to monitor this.

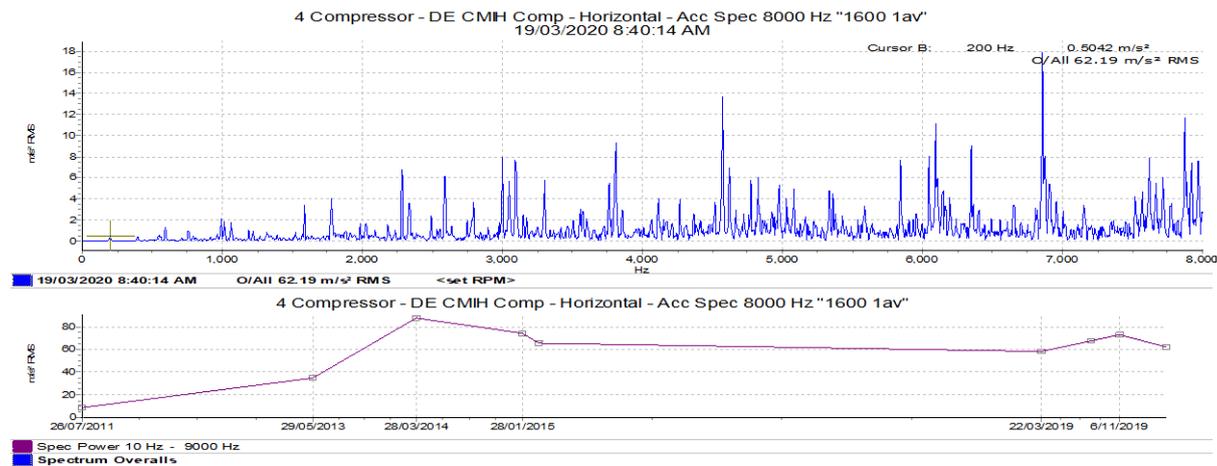
[NH3 Compressor - DE CMIH Comp - Horizontal - Acc Spec 8000 Hz "1600 1av"](#)

Power 10 Hz - 9000 Hz Danger by 138.2% (Danger). The compressor input bearing has a critical stage bearing wear alarm. The historical trend shows no increase. This requires a replacement bearing as soon as possible; I will continue to monitor this.

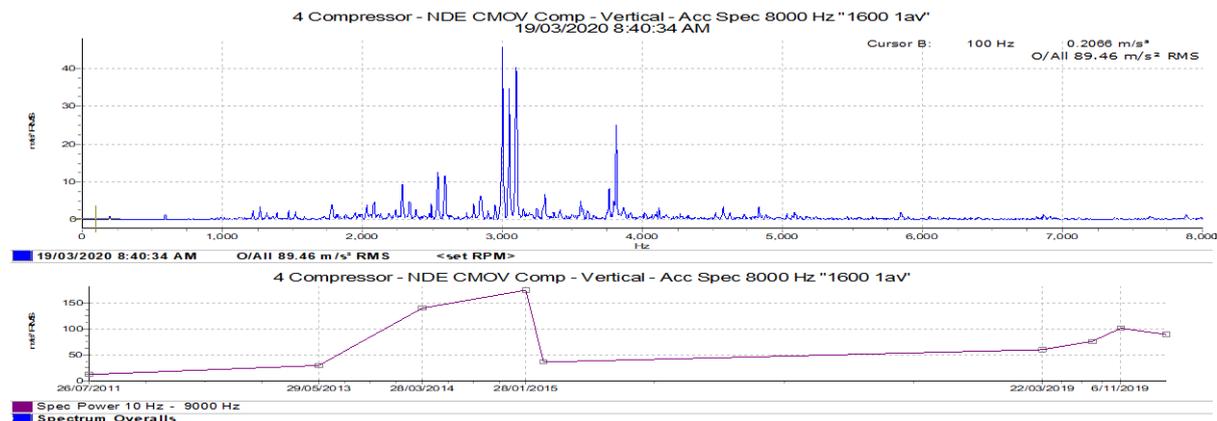
[NH3 Compressor - NDE CMOV Comp - Vertical - Acc Spec 8000 Hz "1600 1av"](#)

Power 10 Hz - 9000 Hz Danger by 198.8% (Danger). The compressor male output bearing has an acute stage bearing wear alarm. The historical trend shows no increase. This requires a replacement bearing as soon as possible; I will continue to monitor this.

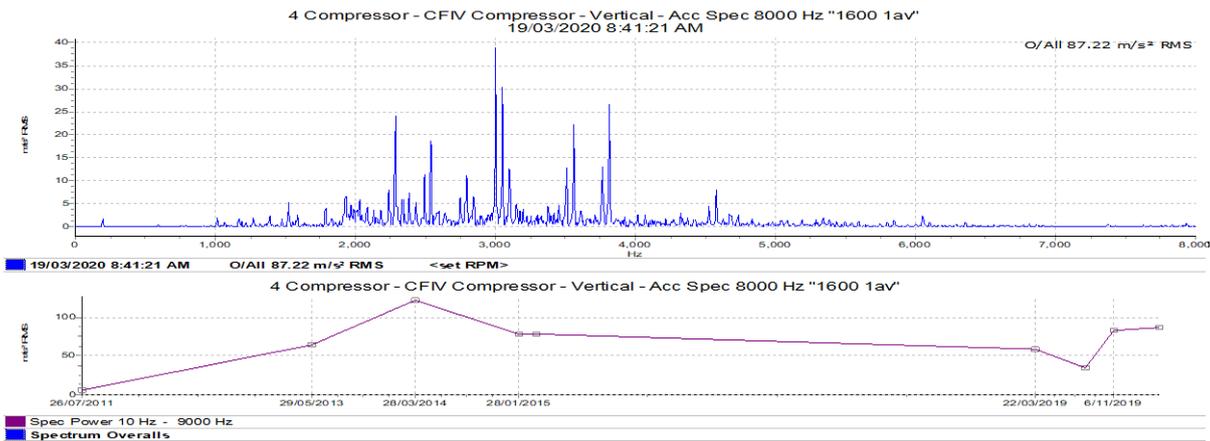
NH3 Compressor - CFIV Compressor - Vertical - Acc Spec 8000 Hz "1600 1av"

Power 10 Hz - 9000 Hz Danger by 193.8% (Danger). The compressor female input bearing has an acute stage bearing wear alarm. The historical trend shows no increase. This requires a replacement bearing as soon as possible; I will continue to monitor this.

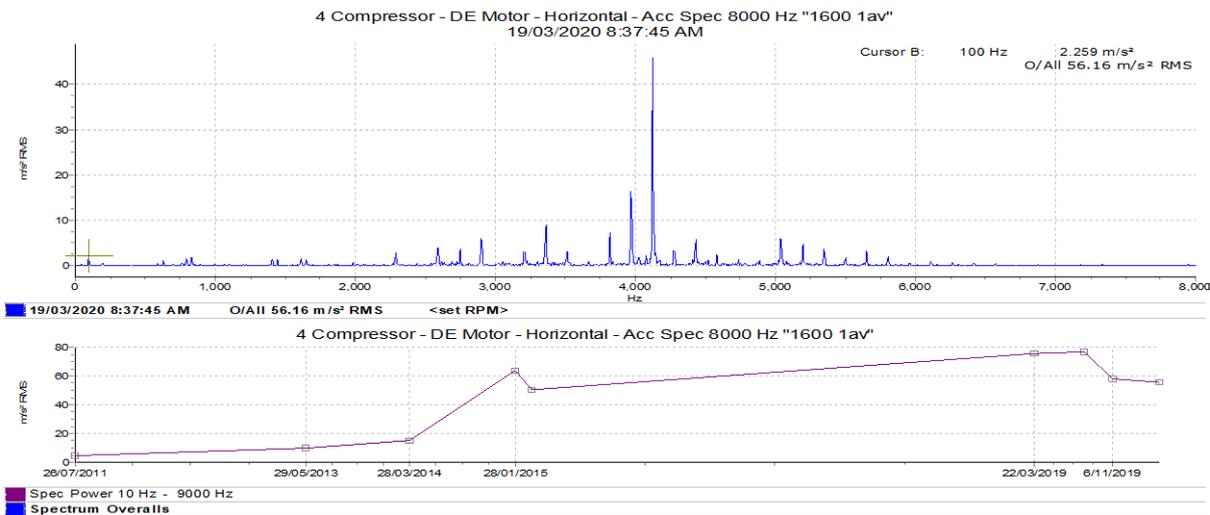
NH3 Compressor - DE Motor - Horizontal - Acc Spec 8000 Hz "1600 1av"

Power 10 Hz - 9000 Hz Danger by 124.8% (Danger). The motor drive bearing has a critical stage bearing wear alarm. The historical trend shows no increase. This requires a replacement bearing as soon as possible; I will continue to monitor this.

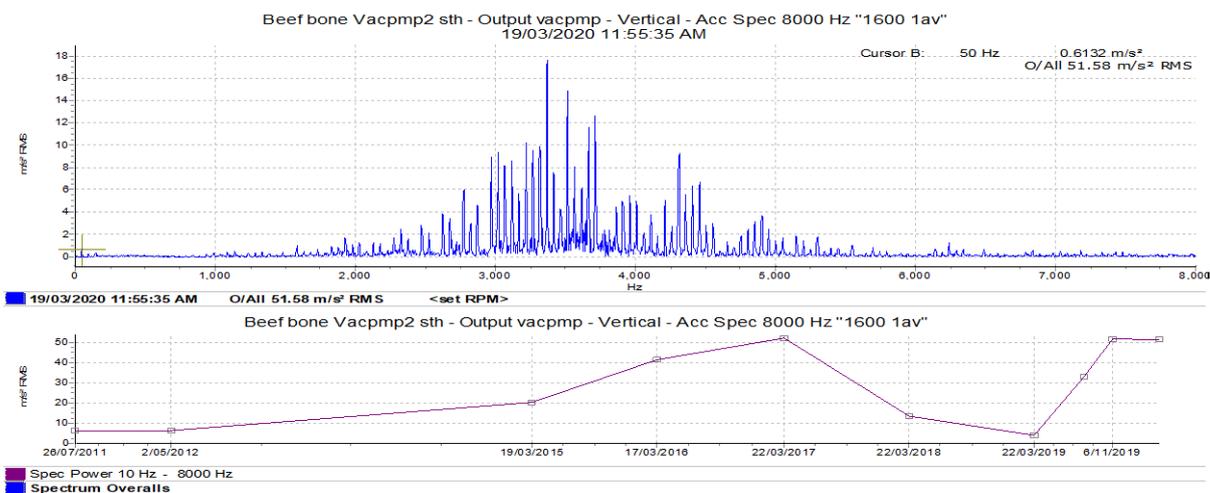
Vacuum pump #2 sth - Output vacpmp - Vertical - Acc Spec 8000 Hz "1600 1av"

Power 10 Hz - 8000 Hz Danger by 114.6% (Danger). The vac. pump output bearing has a critical stage bearing wear alarm. The historical trend shows no increase. This requires a replacement bearing as soon as possible; I will continue to monitor this.

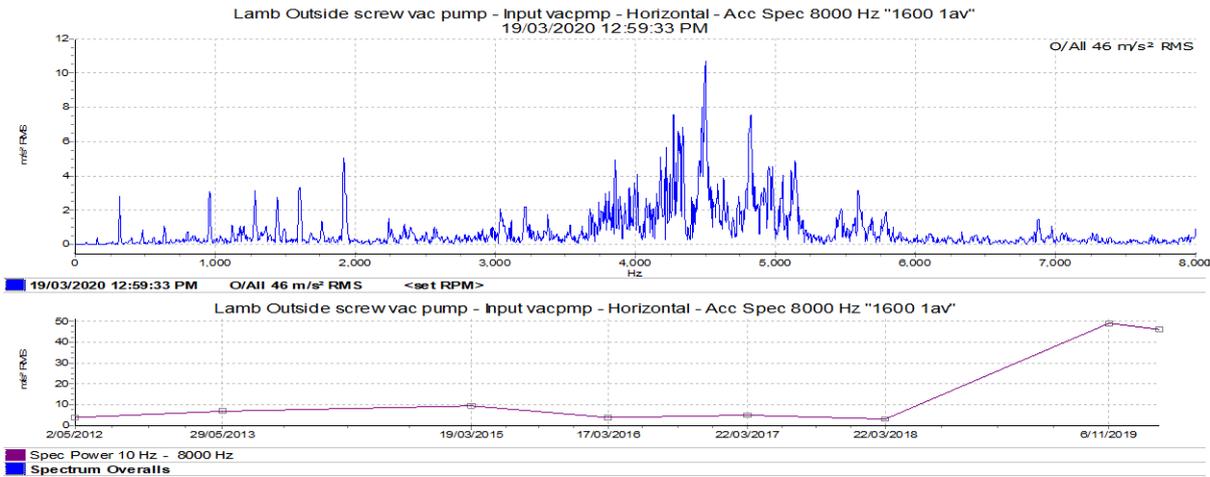
[Screw vac pump - Input vacpmp - Horizontal - Acc Spec 8000 Hz "1600 1av"](#)

Power 10 Hz - 8000 Hz Danger by 102.2% (Danger). The screw input bearing has a second stage bearing wear alarm. The historical trend shows no increase. This requires a replacement bearing when possible; I will continue to monitor this.

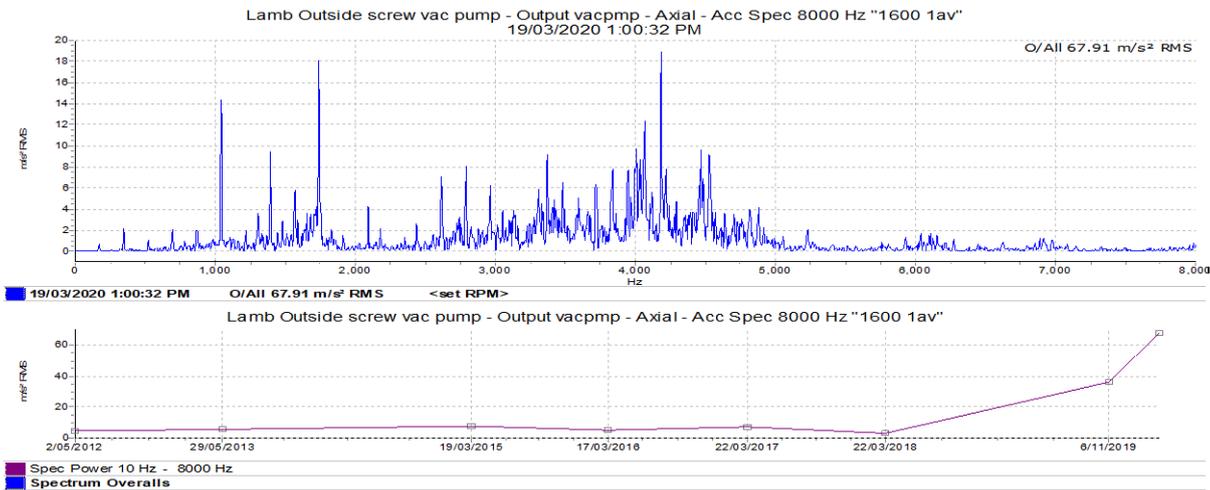
[Screw vac pump - Output vacpmp - Axial - Acc Spec 8000 Hz "1600 1av"](#)

Power 10 Hz - 8000 Hz Danger by 150.9% (Danger). The screw output bearing has a critical stage bearing wear alarm. The historical trend shows a rapid increase. This requires a replacement bearing as soon as possible; I will continue to monitor this.

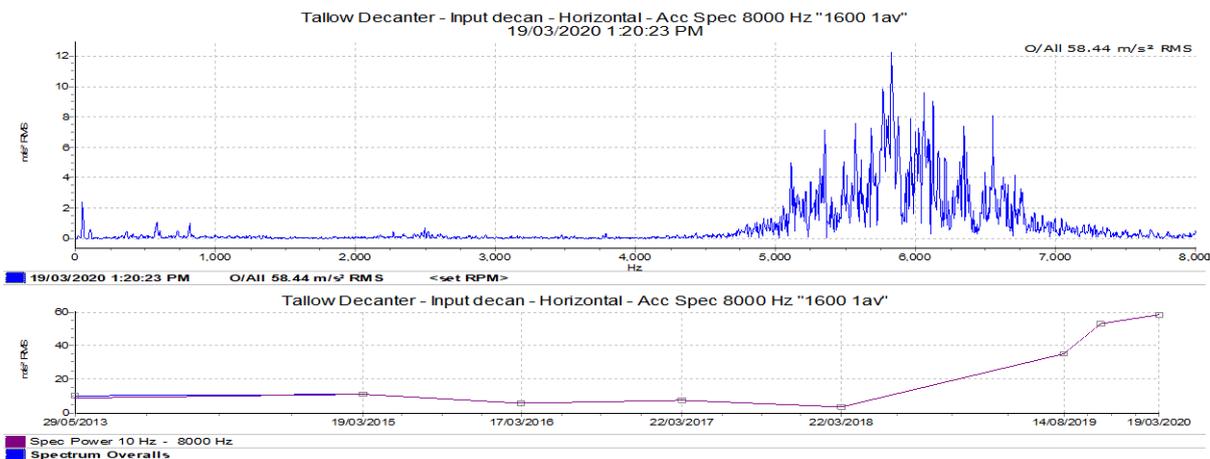
[Tallow Decanter - Input decan - Horizontal - Acc Spec 8000 Hz "1600 1av"](#)

Power 10 Hz - 8000 Hz Danger by 129.9% (Danger) The decanter input bearing has a critical stage bearing wear alarm. The historical trend shows a rapid increase. This requires a replacement bearing as soon as possible; I will continue to monitor this.

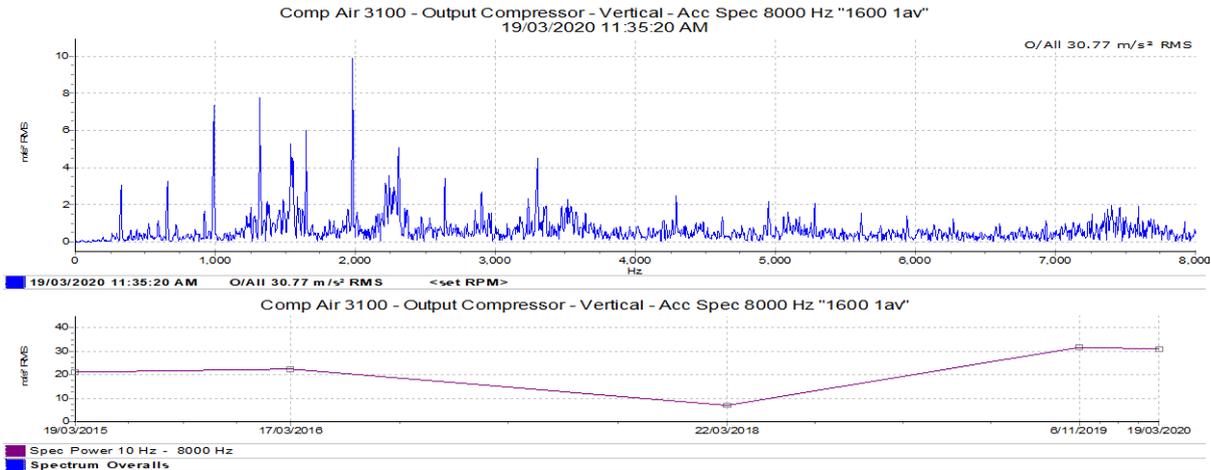
Comp Air 3100 - Output Compressor - Vertical - Acc Spec 8000 Hz "1600 1av"

Power 10 Hz - 8000 Hz Alert by 102.6% (Alert). The compressor output bearing has a second stage bearing wear alarm. The historical trend shows no increase. This requires lubrication and further attention; I will continue to monitor this.

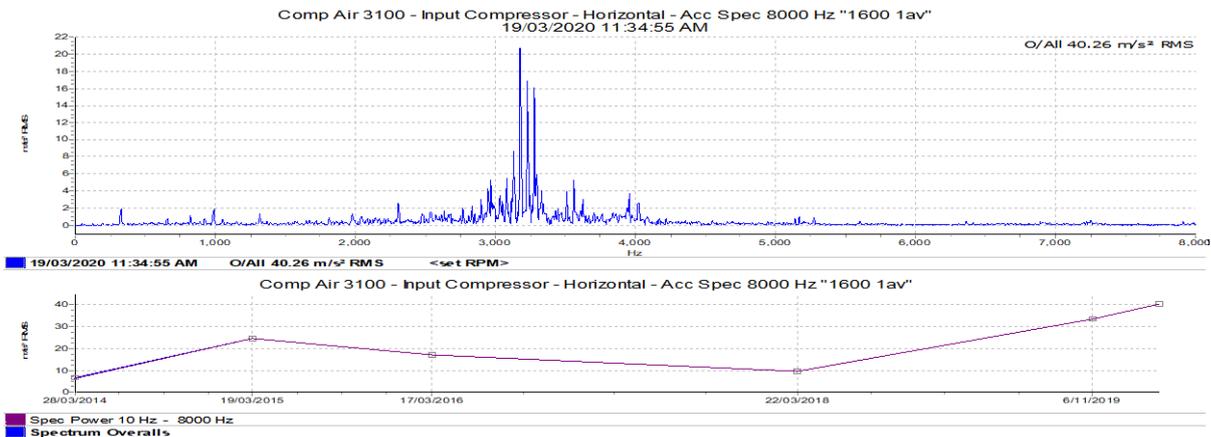
Comp Air 3100 - Input Compressor - Horizontal - Acc Spec 8000 Hz "1600 1av"

Power 10 Hz - 8000 Hz Alert by 134.2% (Alert). The compressor input bearing has a second stage bearing wear alarm. The historical trend shows a rapid increase. This requires a replacement bearing when possible; I will continue to monitor this.

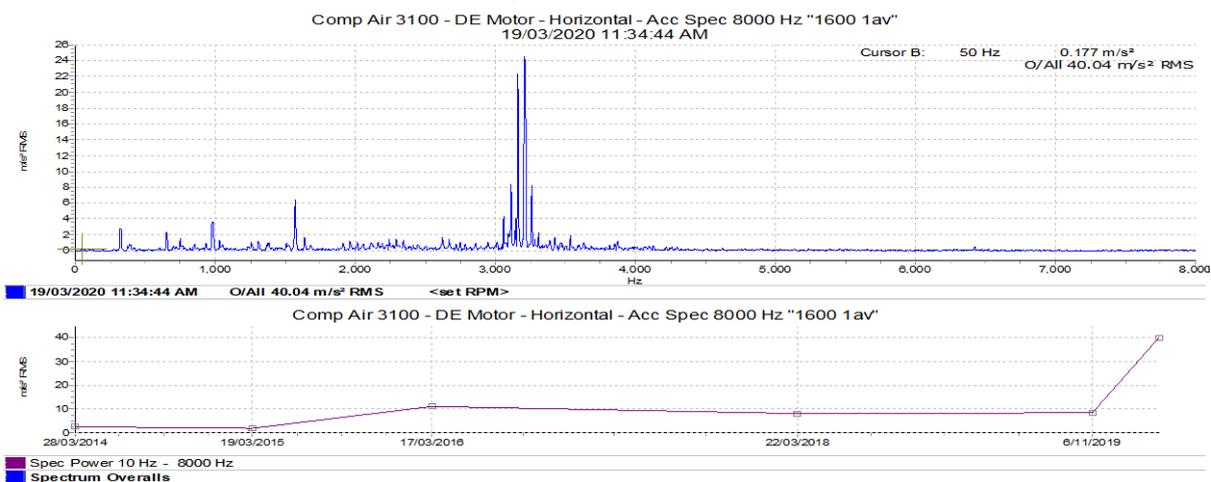
Air Compressor 3100 - DE Motor - Horizontal - Acc Spec 8000 Hz "1600 1av"

Power 10 Hz - 8000 Hz Alert by 133.5% (Alert). The motor drive end bearing has a second stage bearing wear alarm. The historical trend shows a rapid increase. This requires a replacement bearing when possible; I will continue to monitor this.

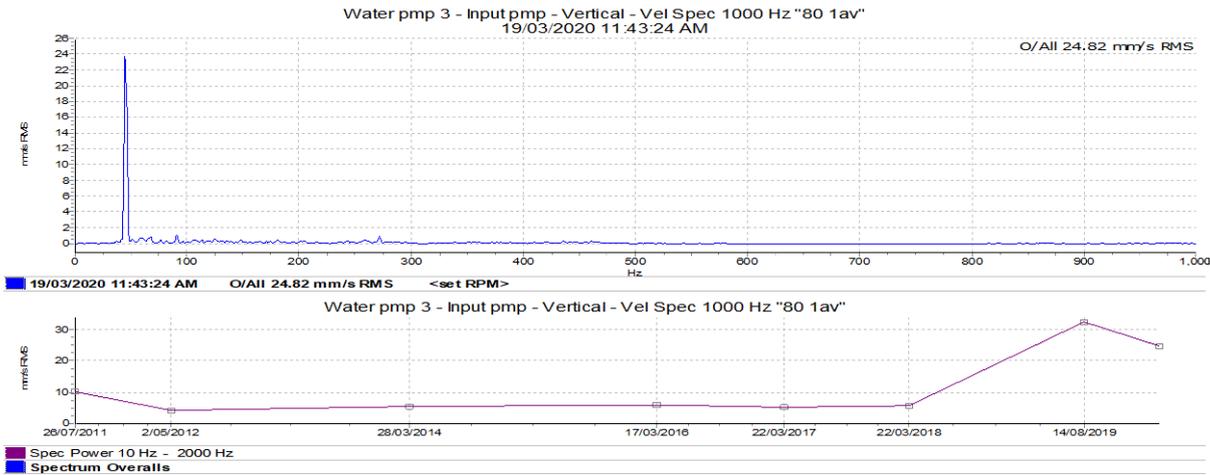
[Water pmp 3 - Input pmp - Vertical - Vel Spec 1000 Hz "80 1av"](#)

Power 10 Hz - 2000 Hz Alert by 124.1% (**Alert**). The pump has a second stage coupling alignment alarm, this requires realigning as soon as possible. Check coupling condition.

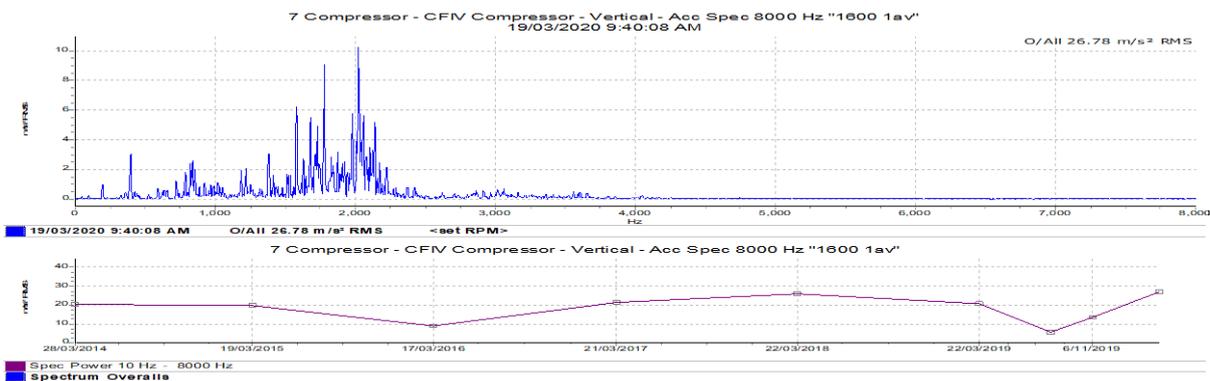
[7 Compressor - CFIV Compressor - Vertical - Acc Spec 8000 Hz "1600 1av"](#)

Power 10 Hz - 8000 Hz Warning by 133.9% (**Warning**). The compressor female input bearing has a first stage wear alarm. The 50hz defects are electrical discharge. The historical trend shows an increase in amplitude.

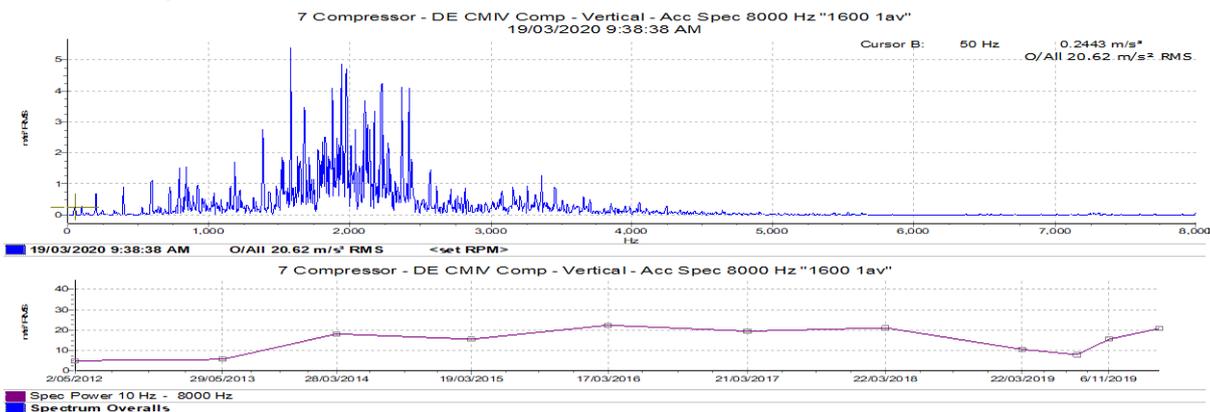
[7 Compressor - DE CMIV Comp - Vertical - Acc Spec 8000 Hz "1600 1av"](#)

Power 10 Hz - 8000 Hz Warning by 103.1% (**Warning**). The compressor male input bearing has a first stage wear alarm. The 50hz defects are electrical discharge. The historical trend shows an increase in amplitude.

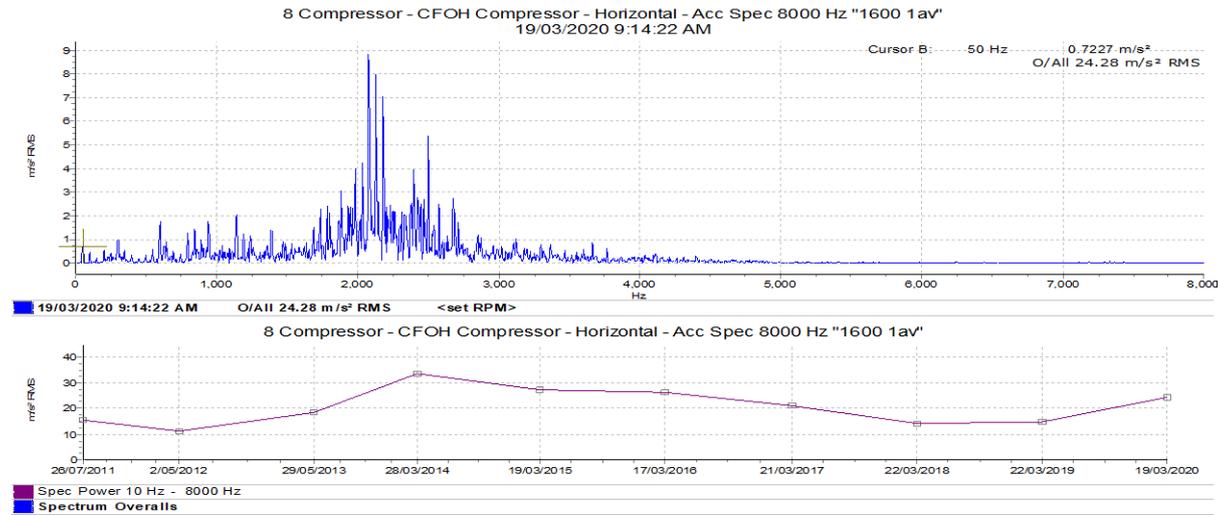
[8 Compressor - CFOH Compressor - Horizontal - Acc Spec 8000 Hz "1600 1av"](#)

Power 10 Hz - 8000 Hz Warning by 121.4% (Warning). The compressor female output bearing has a first stage wear alarm. The 50hz defects are electrical discharge. The historical trend shows an increase in amplitude.
